TWR-60834

RSRM Top Hat Cover Simulator Lightning Test Final Report

Volume I

July 1990

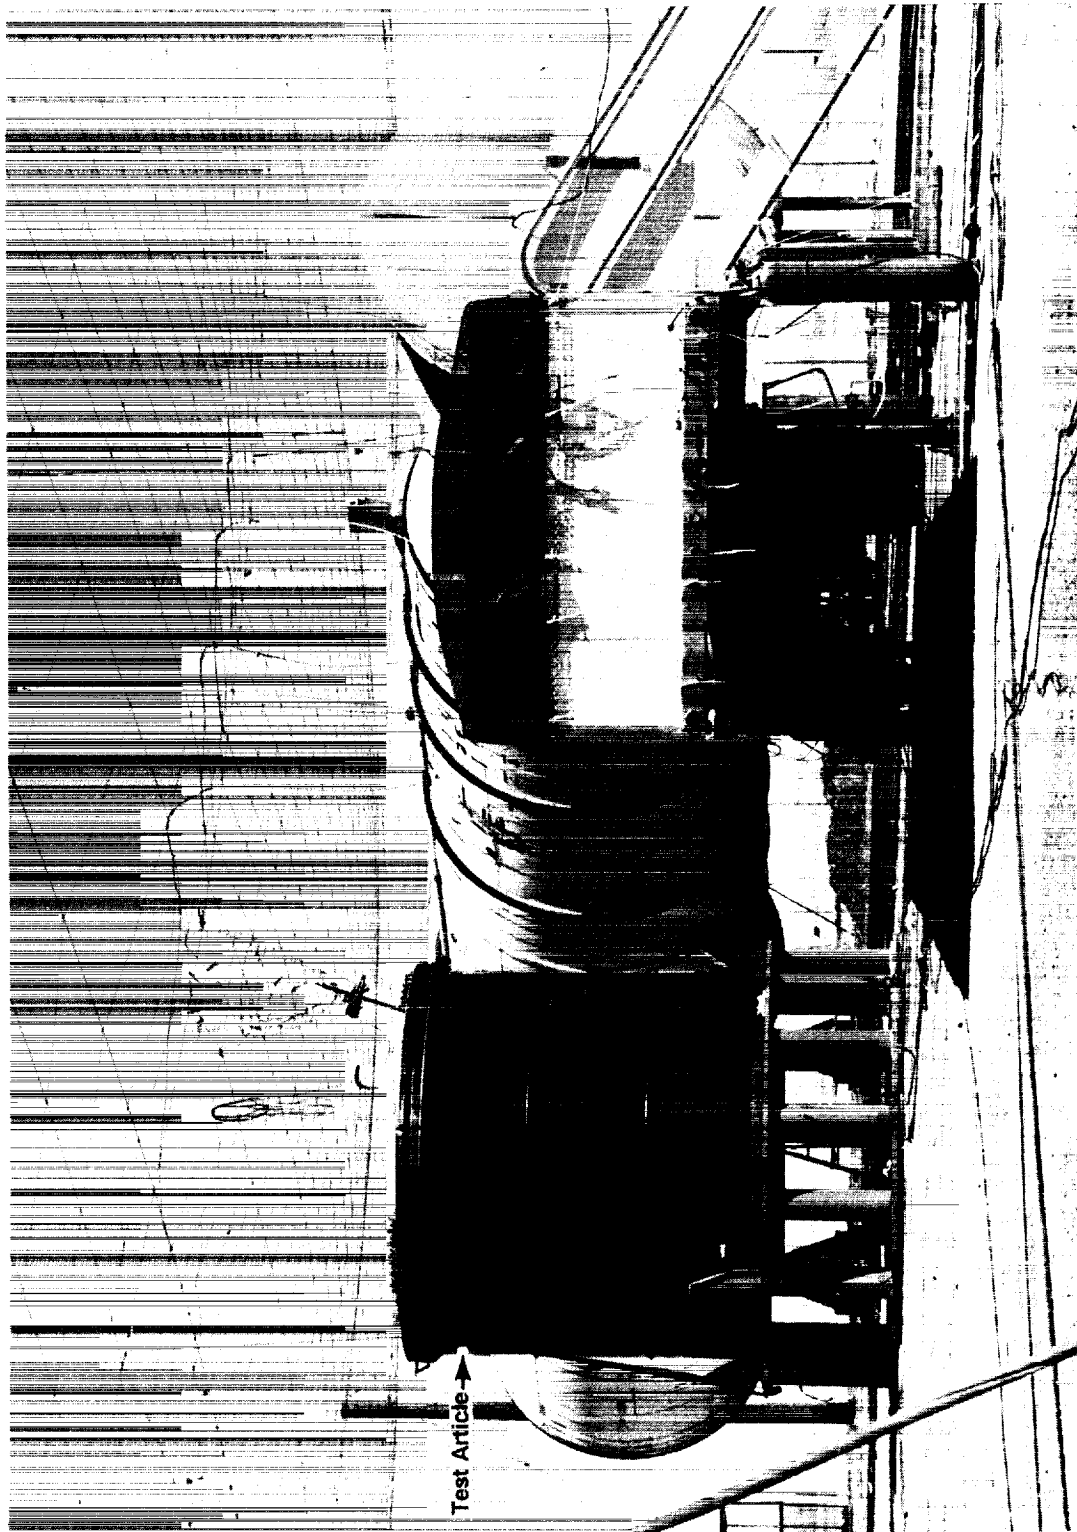
Figure 1. RSRM Top Hat Cover Simulator Test Article

The test article was placed between two horizontal grids of a peaking capacitor (Figure 1). The peaking capacitor has a 9-m distance between two parallel grids. The two parallel 2,500-m² wire grids (upper and lower) make up two plates of a 2.5-nano-farad (nF) capacitor.

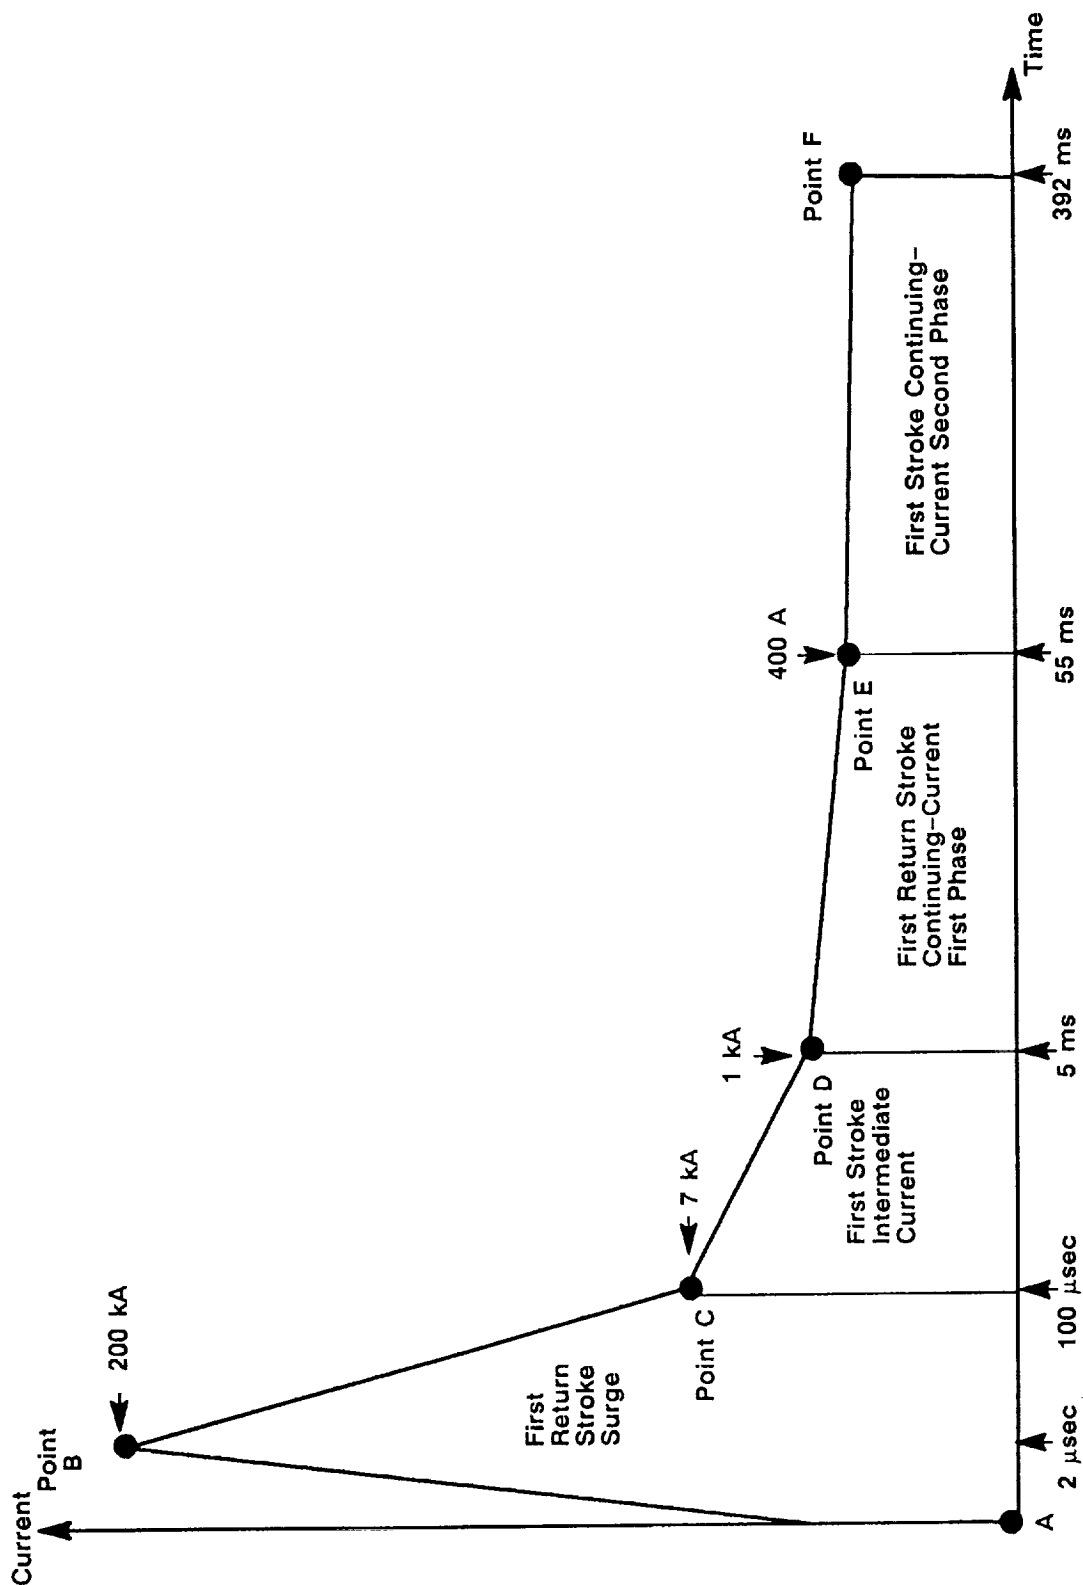
Figure 2. Worst-Case Model of Lightning Discharge

simulated the fast rise in current with respect to time of a worst-case lightning discharge to unprotected flight hardware on the ground (Figure 2, points A - B), as defined in NSTS 07636, Rev D.

The high current bank (HCB) simulated lightning discharges were by direct arc attachment to the top hat cover simulator and the mounting bolts. The HCB simulated the peak current of a worst-case lightning discharge to unprotected flight hardware on the ground (Figure 2, points B - C), as defined in NSTS 07636, Rev D.

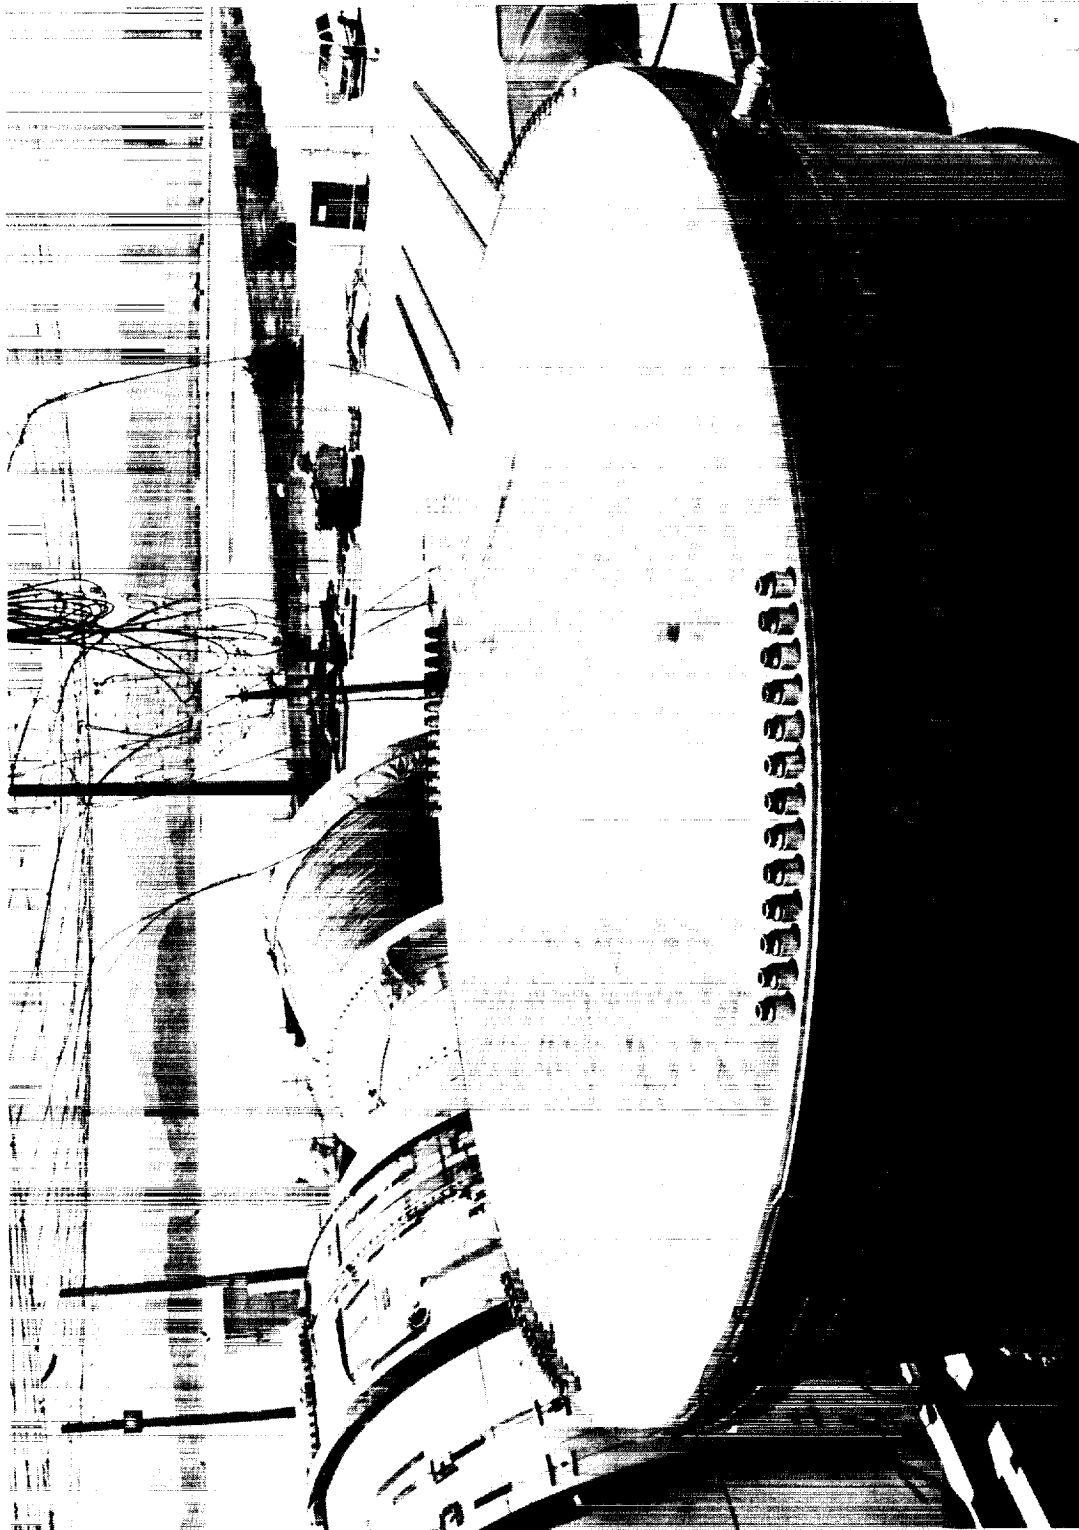
Figure 3. Top Hat Cover Simulator Mounted Onto Test Article

Test article Configuration No. 2 consisted of a test stand placed on the lower capacitor grid with an empty RSRM case segment (1U50715-02) mounted vertically. Installed around the top edge of the case was a handling ring (8U50943-03), grain cover (8U75816-01), and segmented ring (8U50929-03). Mounted above the grain cover onto the handling ring was a top hat cover simulator (Figure 3). WTP-0245 Configuration No. 2 calls for 0.25-in. shims to be placed between the top hat simulator and the handling ring, which was intended to simulate warping of the cover. During the manufacturing process the top hat simulator warped making the use of shims unnecessary.

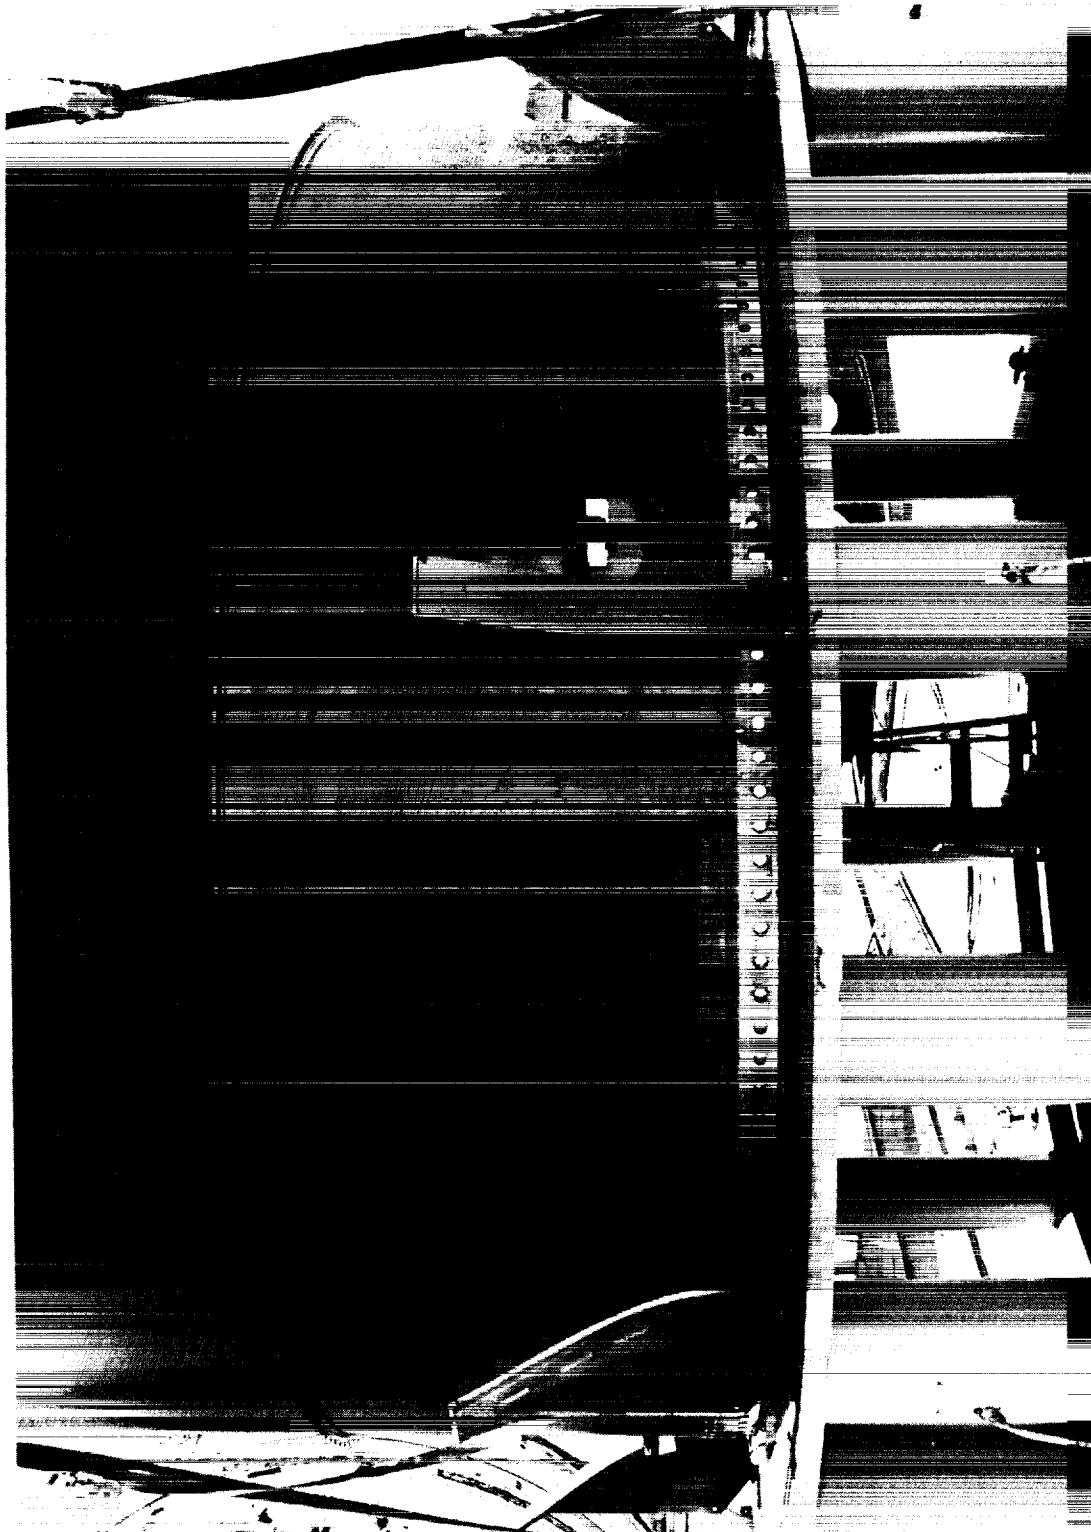
Figure 4. Lightning Detector Mounted Onto Test Article

Four lightning detectors (8U76447) were mounted to the case (Figure 4) using a piece of polystyrene foam and olive drab waterproof tape (Permacel No. P672, Thiokol Corporation Stock No. 57-742061). Two of the detectors had sensitivities less than 500 amperes per meter (A/m), and the other two detectors had sensitivities greater than 500 A/m. The detectors were installed for detection 500 A/m during a Marx discharge to the test article.

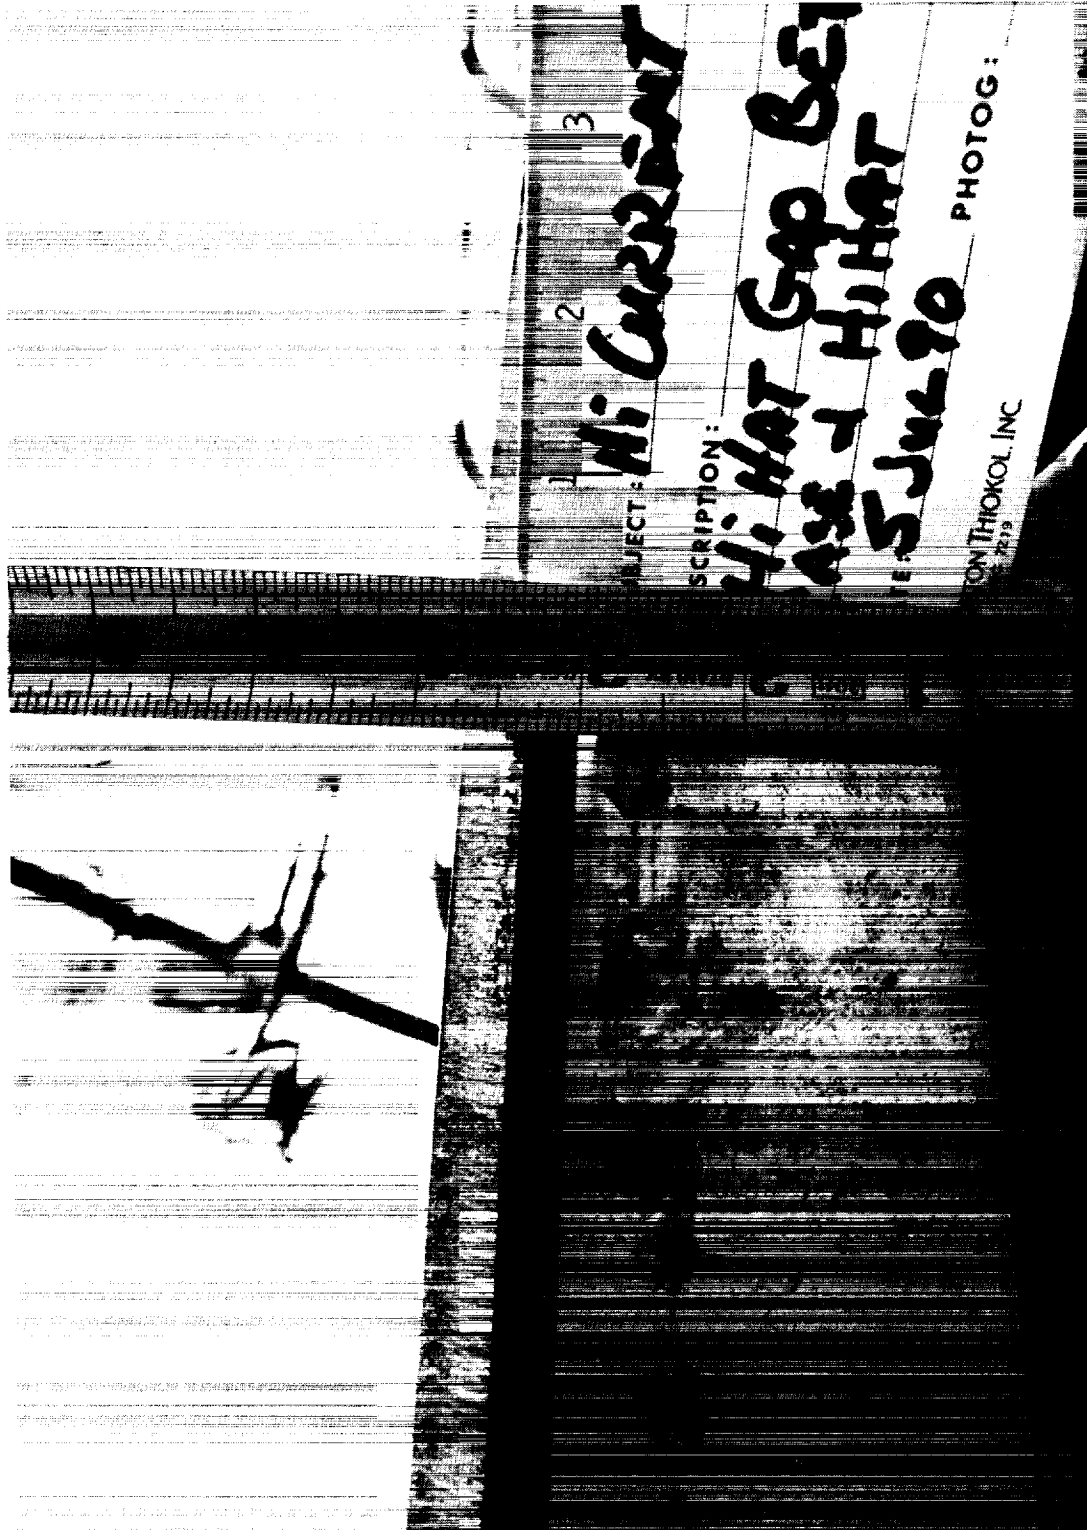
Figure 5. Gap Thickness Between Top Hat Cover Simulator and Handling Ring

This configuration consisted of a test stand placed on the lower parallel peaking capacitor grid, an empty RSRM segment mounted vertically on the test stand, a segmented ring, a handling ring and a top hat cover simulator. This configuration did not include the grain cover. The 0.25-in. shims were not installed between the top hat cover simulator and the handling ring. The shims were not installed because the gap between the top hat cover simulator and the handling ring was a minimum of 0.25 in. at several locations around the circumference of the test article (Figure 5).

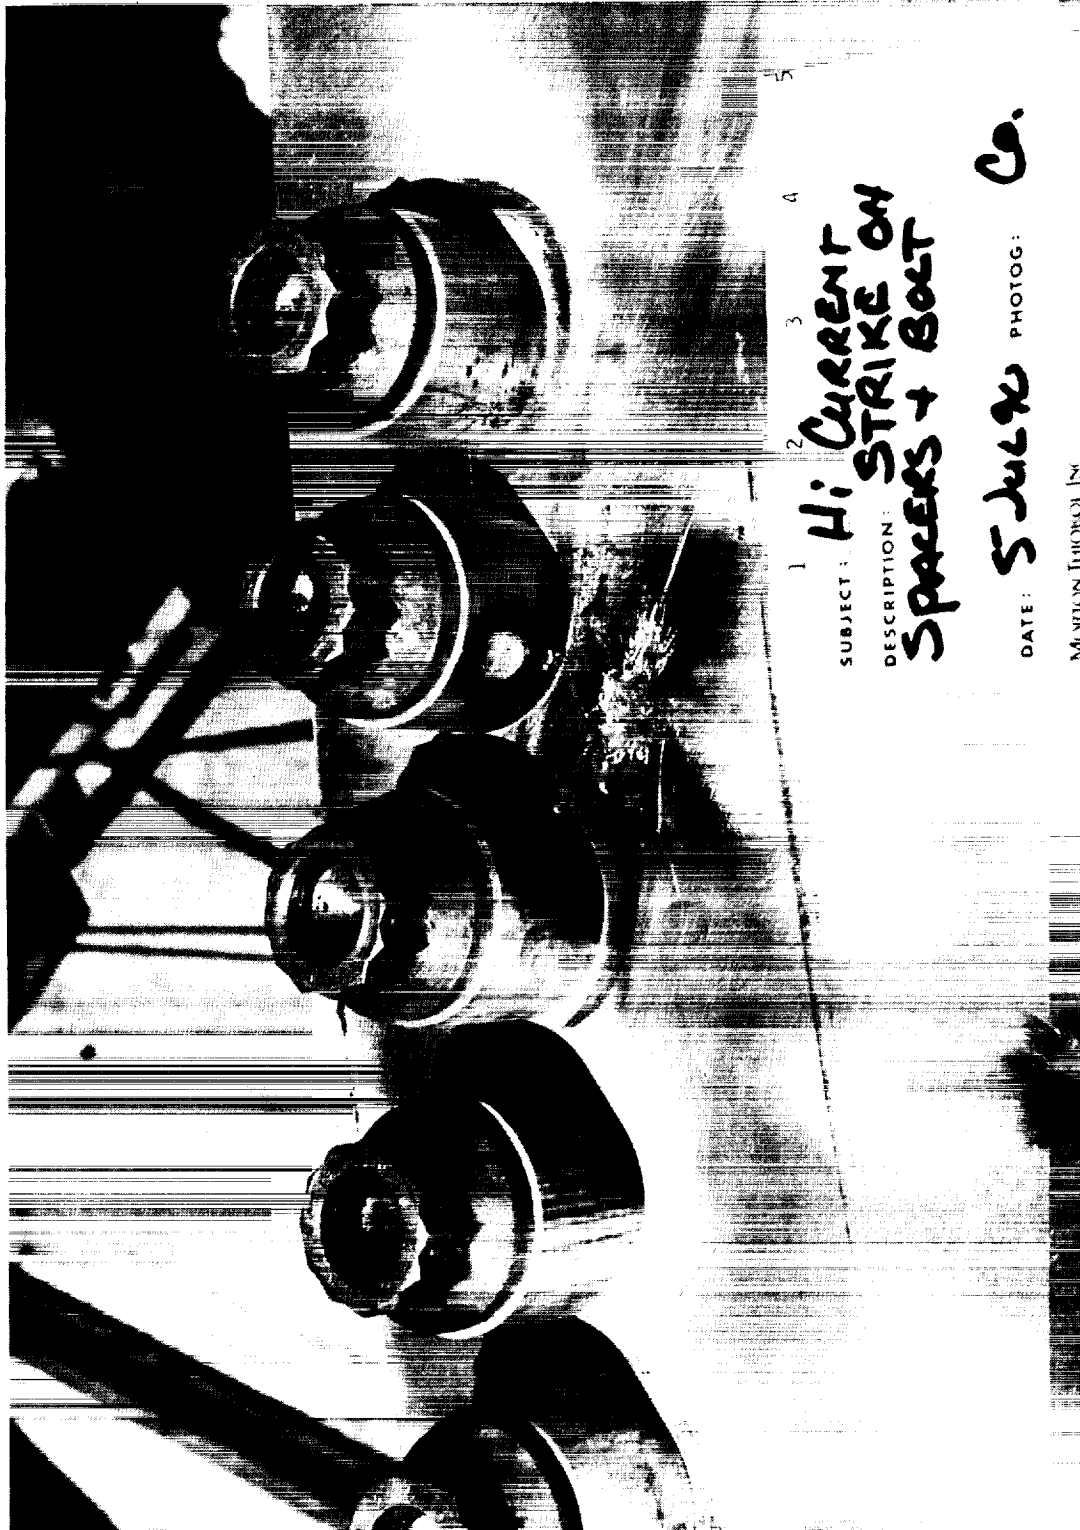
Arcing was observed between hardware components in Configurations No. 2 and No. 3. Arcing was observed between the handling ring and top hat cover simulator in Configuration No. 3 during the last two HCB discharges. Top hat cover simulator and mounting bolt damage (surface scorching, pitting, and melting) was observed (Figures 7 and 8).

Figure 8. Surface Pitting Inflicted Upon Top Hat Cover Simulator

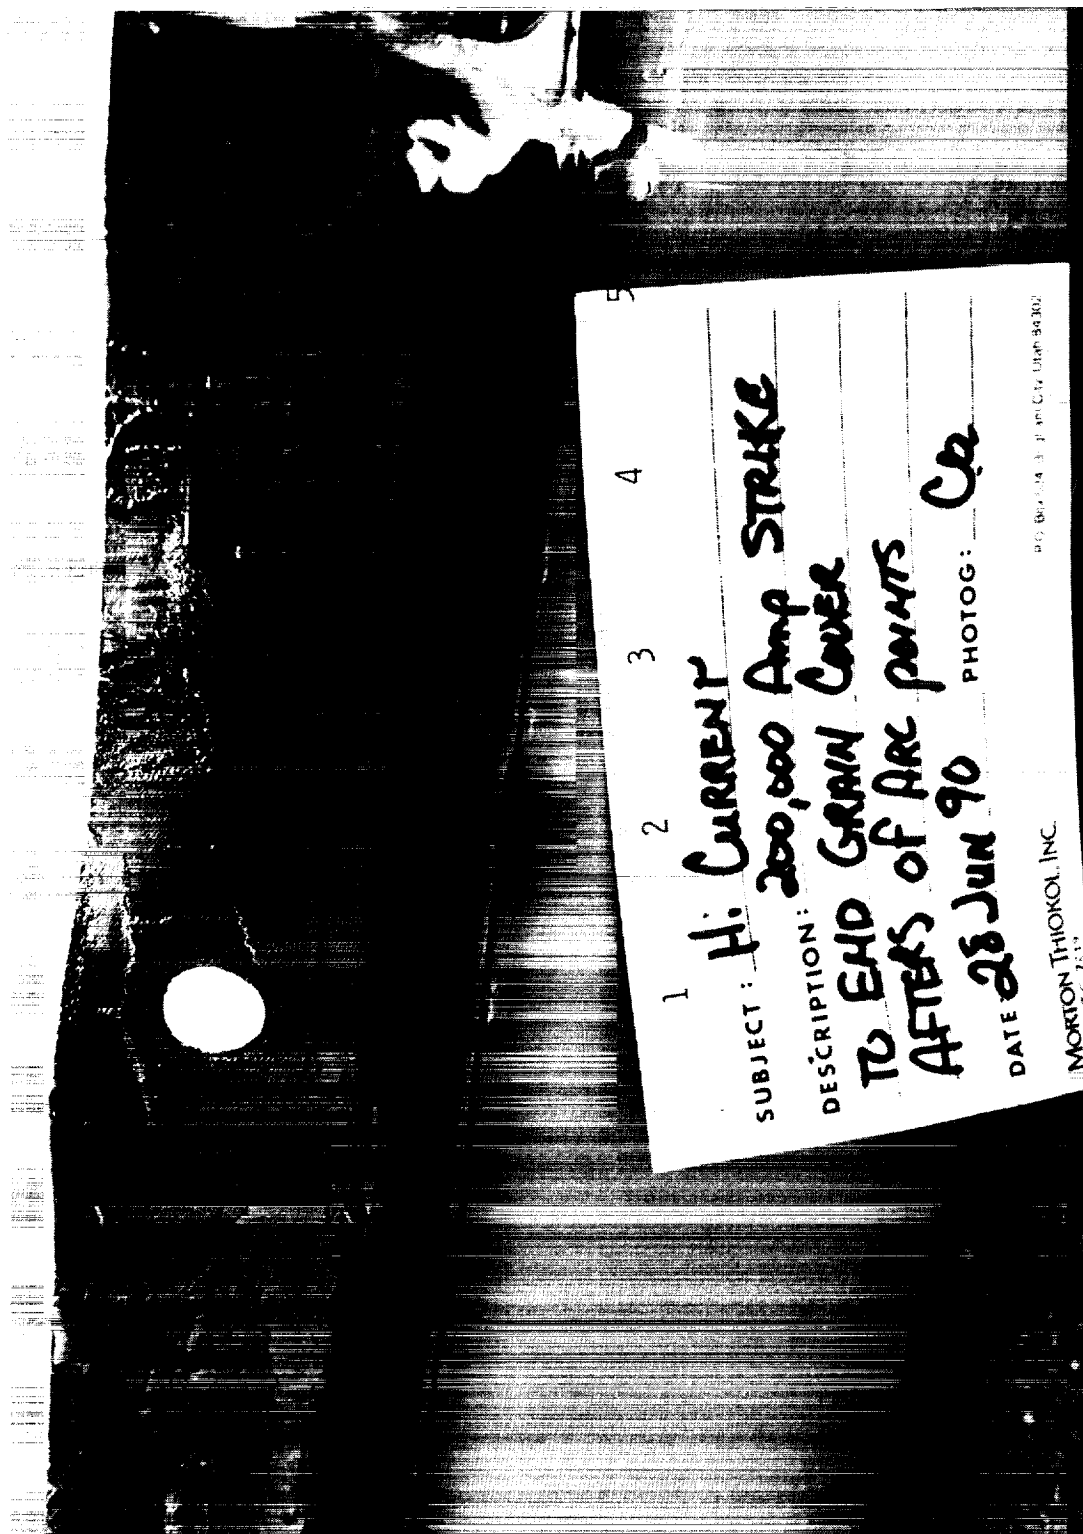
Arcing was observed between the grain cover and the handling ring during the HCB discharges injected onto the test article in Configuration No. 4 (Figure 9). Damage to the grain cover is shown in Figure 10. During HCB discharges injected directly to the grain cover, the fiberglass top was damaged and frayed at the arc attachment point.

Figure 9. Carbon Spot on Grain Cover Proving Unwanted Arcing Occurred (noticed after removal from test article)

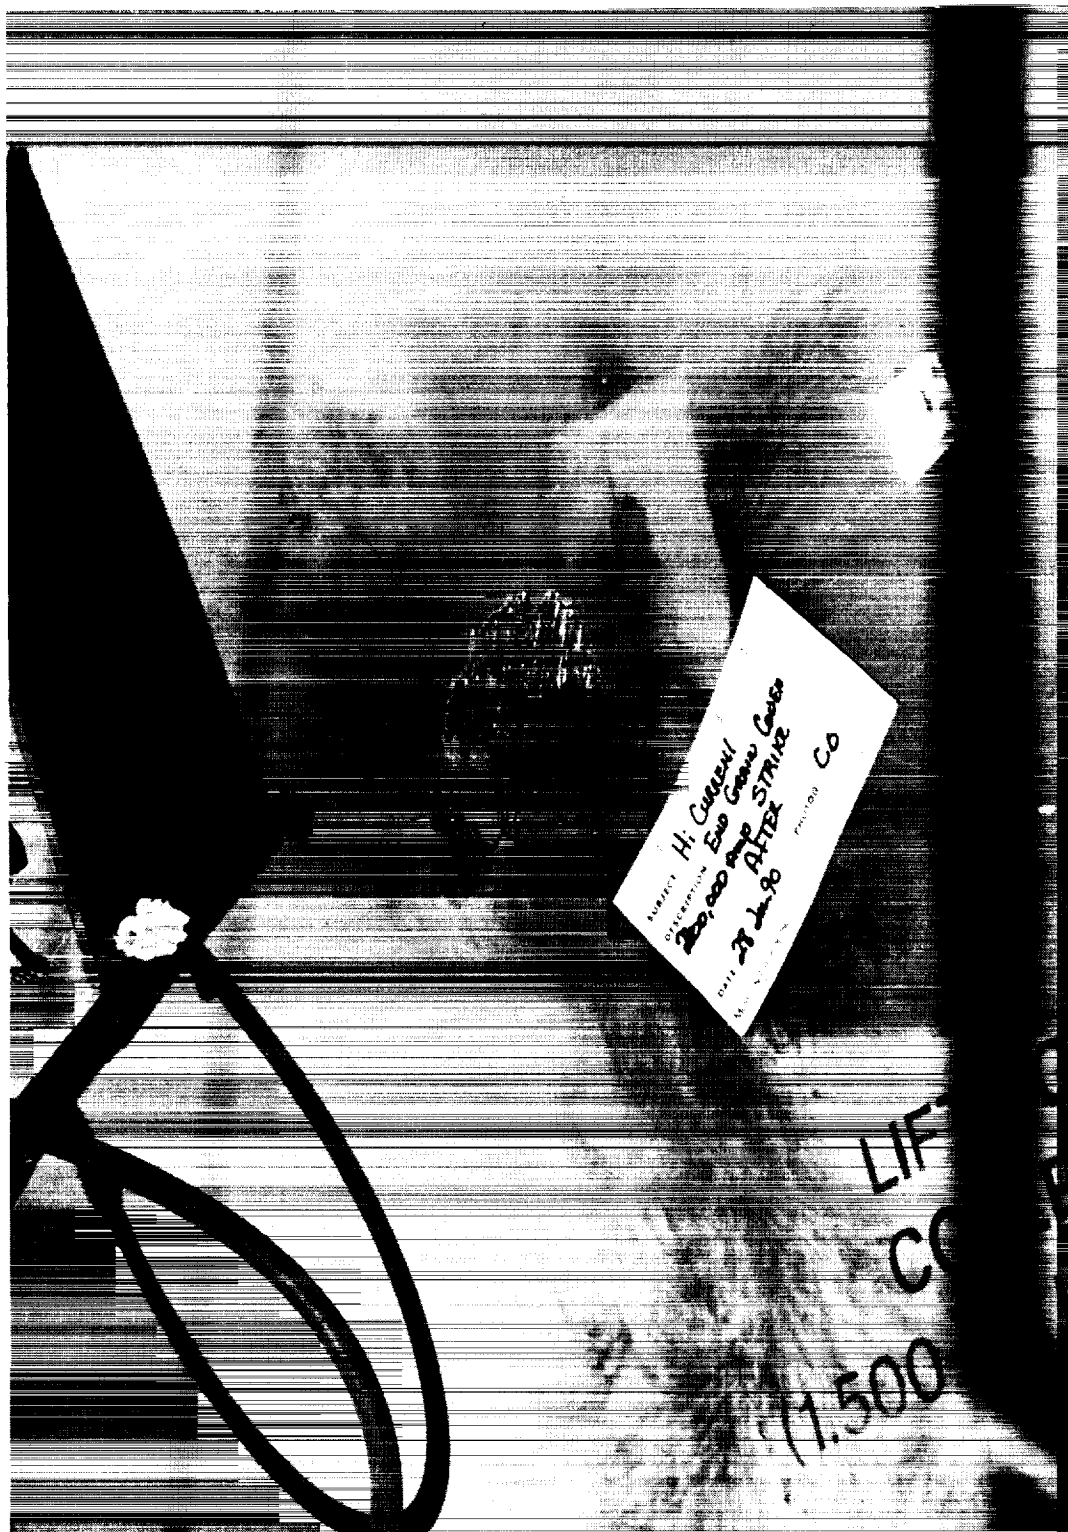
Figure 10. Damage to Grain Cover After Subjection to HCB Discharge
